FORM B – BUILDING

Address 80 Bedford St.

Historic Name George A. Vickery House

Organization Lexington Historical Commission

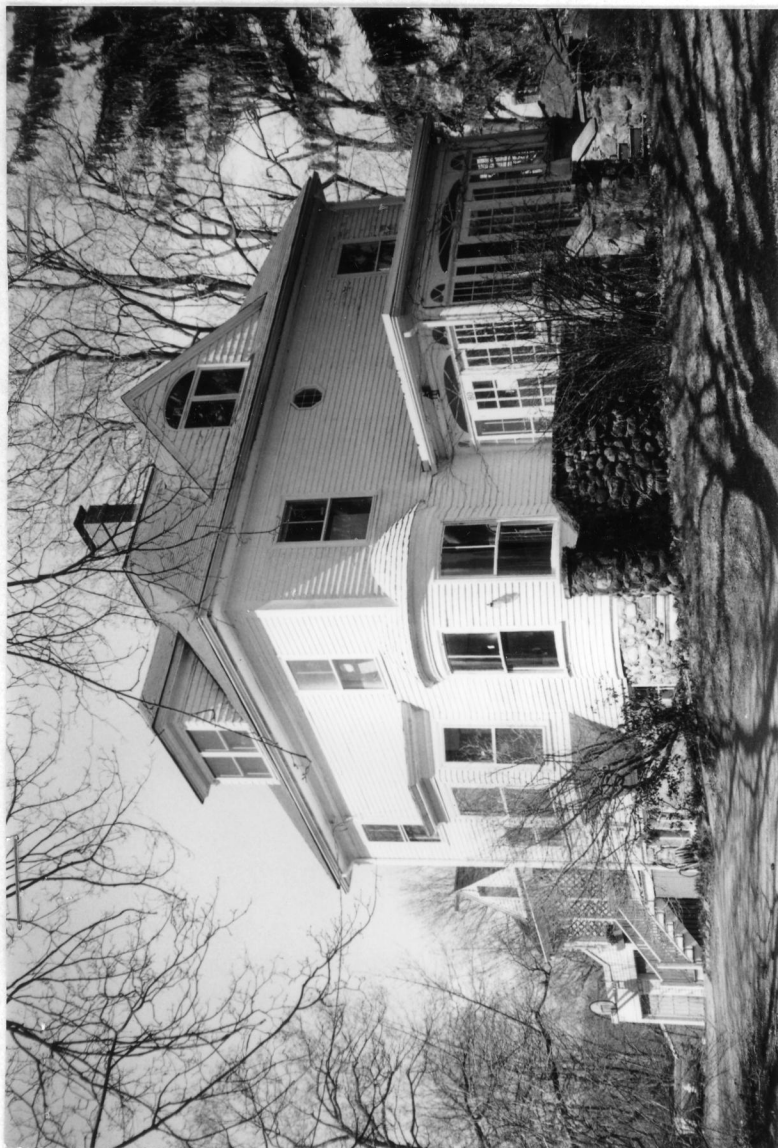
Condition Fair

80 Bedford St. (MHC #750) is one of a number of hip-roofed Colonial Revival houses in Lexington, but is not in as good condition as many others. The house is square, 2½ stories, three-by-three bays, and hip-roofed with a center chimney. It is set on a fieldstone foundation, clad with wood clapboards, and roofed with asphalt shingles. A small hip-roofed rear addition with an exterior chimney is on a concrete block foundation. The front entry, with a stone wall and stairs that appear to be original, is now enclosed in a structure with many windows and elliptical fanlights that is probably a later addition; windows in the house are 2/1 double hung sash. There is a triangular dormer on the front slope of the roof and hipped dormers on the east and west slopes. A small octagonal window is located under the cornice on the facade, a one-story three-sided oriel is on the east elevation, and there is a three-sided bay on the west elevation. A circular one-story bay with a split conical roof is located on the northeast corner. The hip-roofed barn (MHC #751) has a triangular dormer with a hay lift on the front that matches the front dormer of the house. The original part of the barn is now a two-car garage with a flat-roofed extension on the south for two more cars. At the rear, a gabled-addition on the roof is accessed by exterior stairs.
